Manhole Inspection Summary

Manhole # S45G__029MH

Insp Date: **7/15/08 8:16 AM**

Location Address: **241 s. ann st**

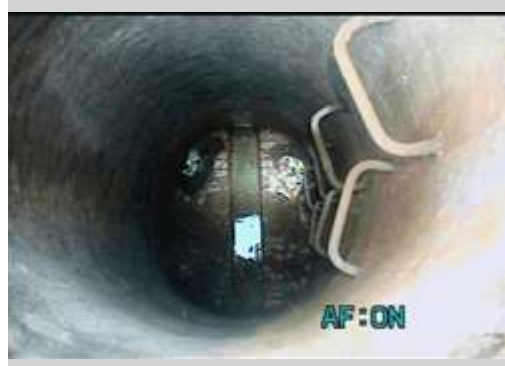
Top View

Top view & Steps

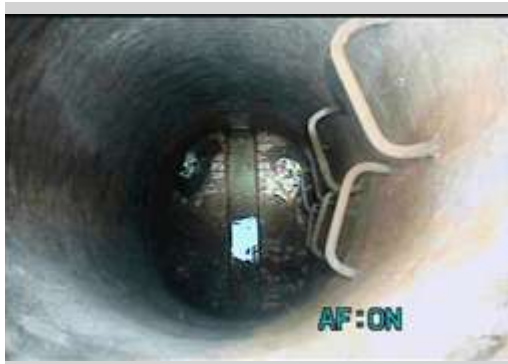
DEFECT 4

Steps Count: **7** Missing: **0** ☒ **Corroded**

CORRODED STEPS

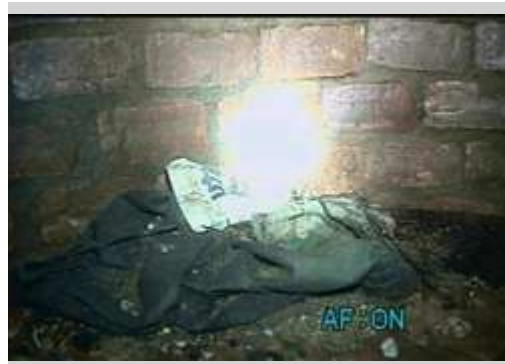
Defect 3

Condition: ☐ Sound ☐ Cracked ☐ Root Intrusion ☐ Deteriorated ☐ Leaks ☒ **Debris**

bench debris

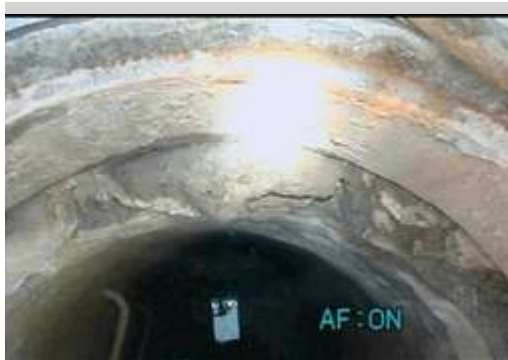
Defect 2

Frame Offset: **3** (in.) Condition: ☒ Sound ☐ Cracked ☐ Leaks

Corbel Material: **Brick** ☒ Parged Type: **Concentric/Eccentric**

frame offset corbel parged

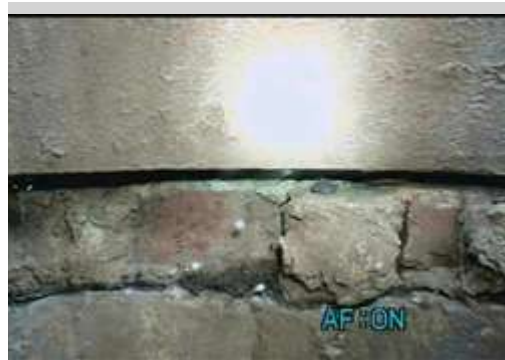
Defect 1

Chimney / Frame Adjustment ☒ Exists Material: **Brick and Concrete** ☐ Parged Height: **4** (in.)

Condition: ☐ Sound ☒ **Cracked** ☐ Root Intrusion ☐ Loose Brick ☐ Deteriorated

chimney loose bricksframe adj

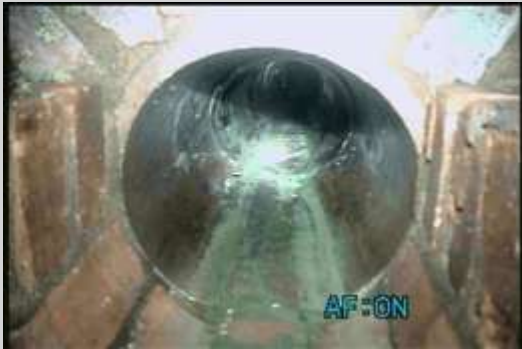
12 O'Clock Outflow

8 in. Circular Gravity Sewer
Pipe Out @ 12 O'Clock

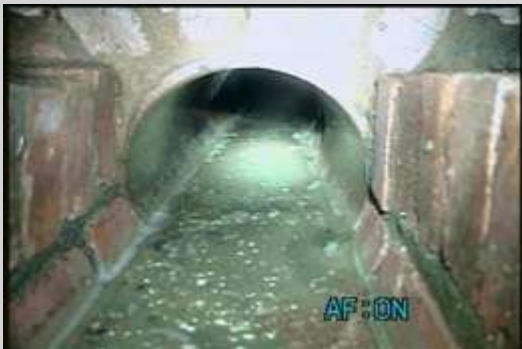
6 O'Clock Inflow

8 in. Circular Gravity Sewer
Pipe In @ 6 O'Clock
